AlphaPlate mixer wear tiles trump performance of chill cast steel

In brief

- Leading national concrete block manufacturer
- Engineering Manager wanted to extend service life of wear parts in two planetary mixers
- OEM chill cast steel floor tiles prone to failure after 2 years
- Installed AlphaPlate hardweld floor tiles

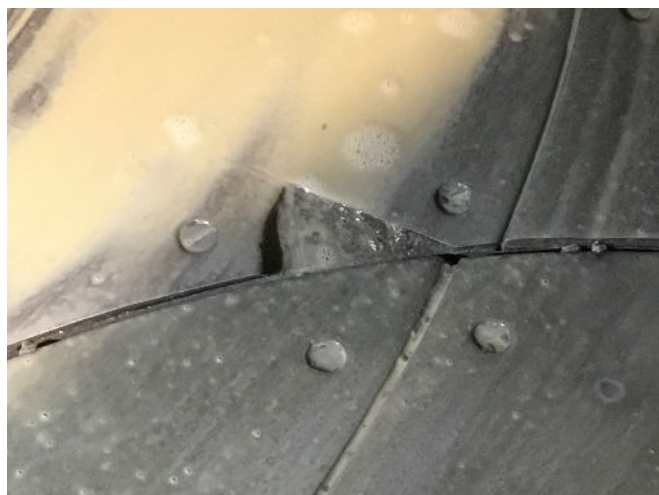
Whilst highly abrasion resistant, the chill cast floor tiles being used in the two 2m³ planetary mixers were suffering from impact damage. Tiles in and around the discharge doors would crack and fail, which would typically lead to the whole set of tiles being replaced after around two years of use.

The premature failure of chill cast tiles due to cracking was increasing the frequency with which the customer had to enter the mixer to carry out maintenance and replace tiles. This led to increased downtime, tile costs and maintenance costs.

Example of a cracked chill cast steel tile

After speaking to ConSpare, the Engineering Manager on site decided to trial a set of AlphaPlate tiles. AlphaPlate hardweld coated tiles are both extremely hard (64 Rockwell) and extremely tough, giving them excellent levels of both abrasion resistance and impact resistance.

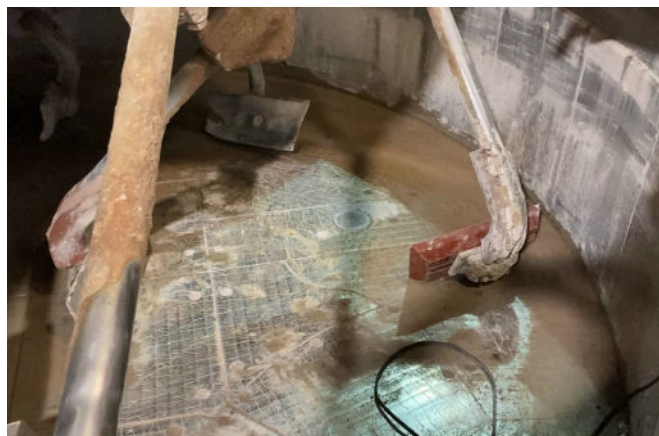
In this application sets of chill cast tiles were being replaced every two years due to wear and tile breakage, however the AlphaPlate tiles were still performing well after two years with no breakages. ConSpare offered to conduct a detailed inspection of the tiles at this point.

The surface of the tiles was inspected via both traditional methods and by 3D scanner, with only minimal wear and not a single damaged tile found. A maximum wear of 1mm-2mm was found in localised zones and significantly less than this was seen in the rest of the surface. Based on this wear rate, the set is expected to last for approximately 7 years.

AlphaPlate 2 year inspection - minimal wear & no damage

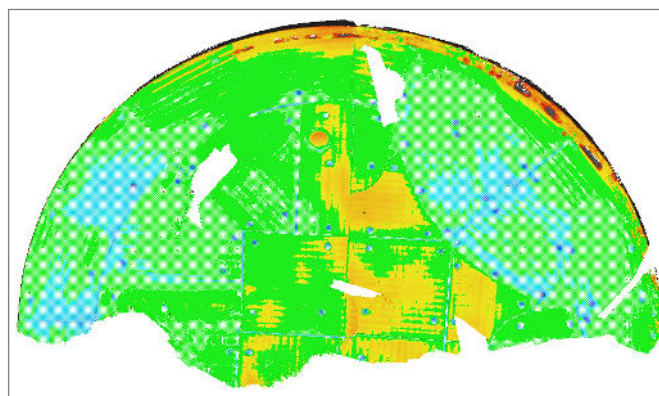
3D scan of AlphaPlate "8+7" tiles after 2 years
