## ConeFlex solves chute cleaning conundrum

### In brief

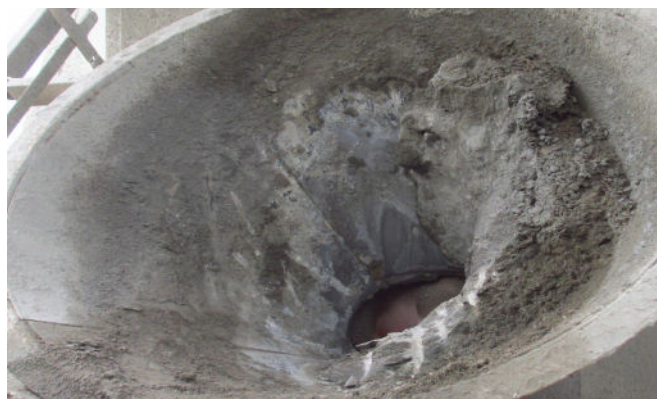
The Site Supervisor at CEMEX Widnes readymix plant was concerned with the build up in their steel discharge cone underneath the pan mixer, which was a major bottleneck interfering with the operation of the plant.

45 minutes manual cleaning of the chute was required each day using a pneumatic hammer to knock the hardened concrete off the cone, creating a potential hand-arm vibration risk to operatives.

Despite daily cleaning, the build up in inaccessible areas worsened over time, requiring intermittent hire of subcontractors to perform a thorough clean. This also required scaffolding hire to gain access and created a working at height risk.

If blocked, the mixer discharge chute becomes a bottleneck, jeopardising production and impacting on mixer operation.

Typical example of build up in steel discharge chute

A ConeFlex abrasion-resistant chute liner was installed to line the steel discharge chute. The low friction 'non-stick' properties of the dual layer Hawiflex polyurethane improved concrete discharge and minimised build up, significantly reducing the cleaning time from four hours a week to just one and eradicating the risk of blockages at the mixer gate.

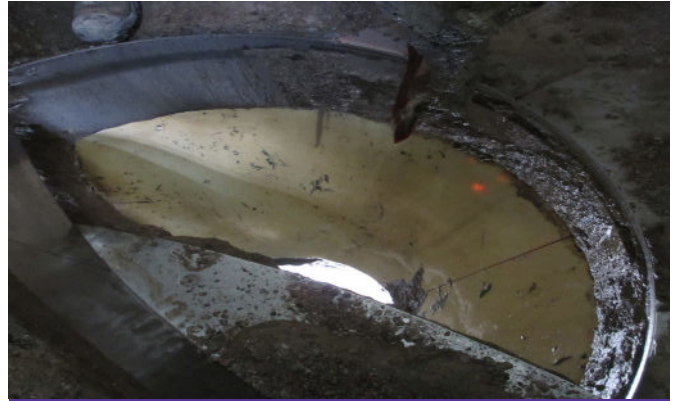
ConeFlex installation at CEMEX Widnes

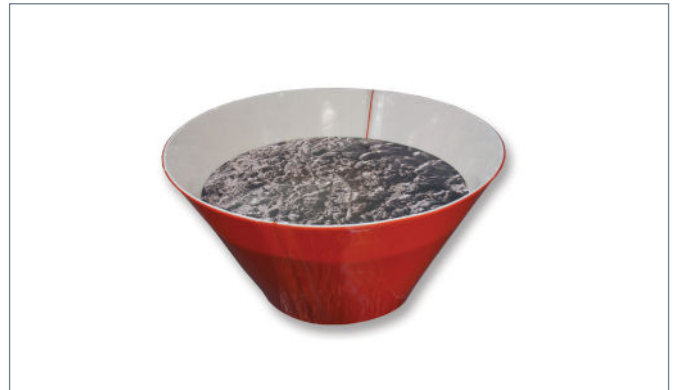
ConeFlex chute liner solution with dual layer wear indicator
