## Wear life increased by 120,000 tonnes: Hawiflex® Wear Lining

**The Challenge:** Abrasive sand, gravel and crushed rock were causing repeated replacement of the steel wear lining in a rotary aggregate feed chute on a high volume readymix plant. Maintenance downtime was causing lost production. The heavy steel plate and inaccessible location made replacement a high risk activity.

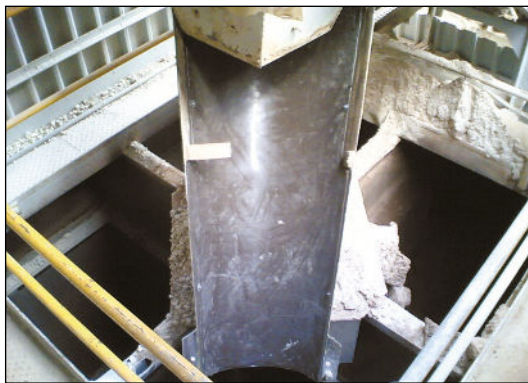
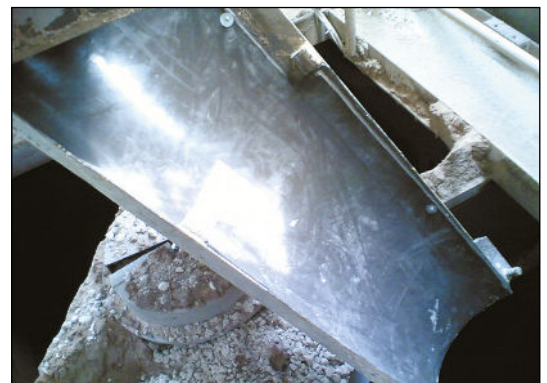
**Our Solution:** Hawiflex® polyurethane bonded with Evostick 528 & bolted

**Improvement:** Steel wear liners: 2 months - 22,500 t  
Hawiflex® wear liners: 36 months - 142,000 t (still operational)
