## Table liner adjustment made a thing of the past: Vibration Table Liners

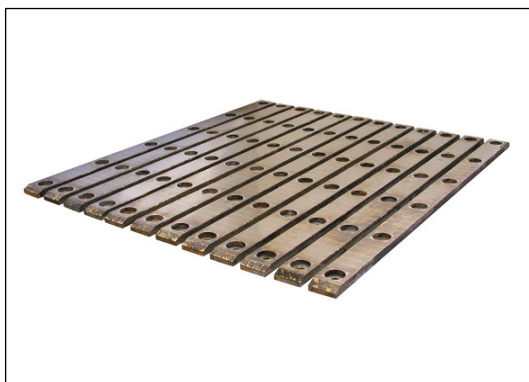
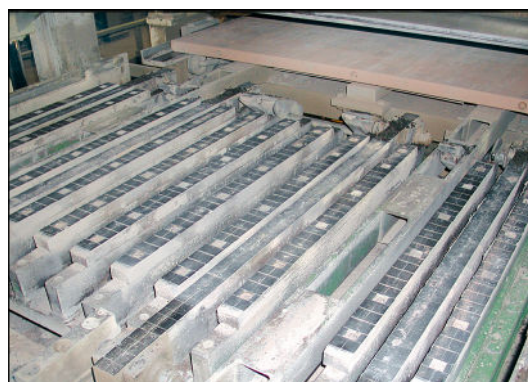
**The Challenge:** A leading manufacturer's vibration table liners on a concrete block machine producing high quality dense blocks were experiencing severe abrasion. The case hardened steel liners were struggling to cope with the demands of high volume production and had a service life of just 10-12 weeks before requiring approximately 5 hours of adjustments.

**Our Solution:** ConSpareUltra tungsten carbide protected vibration table liners

**Key Features:** Highly abrasion-resistant, equivalent to 90+Rockwell

**Improvement:** **Case hardened steel:** 5 hours of adjustment every 3 months  
**UltraTungsten:** No adjustment in over 12 years and still operational
