## ConeFlex solves chute cleaning conundrum

### In brief

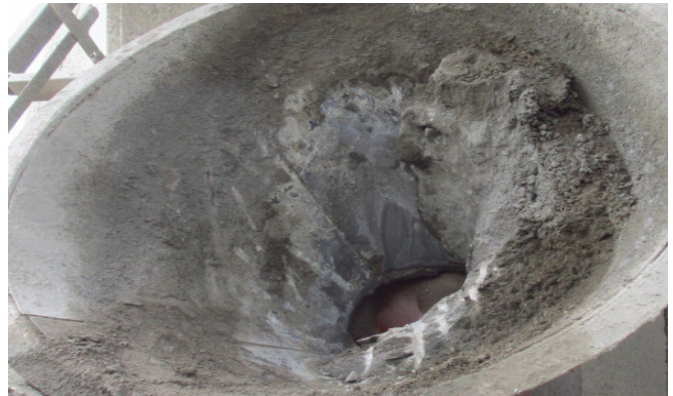
The Site Supervisor at CEMEX Widnes readymix plant was concerned with the build up in their steel discharge cone underneath the pan mixer, which was a major bottleneck interfering with the operation of the plant.

45 minutes manual cleaning of the chute was required each day using a pneumatic hammer to knock the hardened concrete off the cone, creating a potential hand-arm vibration risk to operatives.

Despite daily cleaning, the build up in inaccessible areas worsened over time, requiring intermittent hire of subcontractors to perform a thorough clean. This also required scaffolding hire to gain access and created a working at height risk.

If blocked, the mixer discharge chute becomes a bottleneck, jeopardising production and impacting on mixer operation.

Typical example of build up in steel discharge chute

A ConeFlex abrasion-resistant chute liner was installed to line the steel discharge chute. The low friction 'non-stick' properties of the dual layer Hawiflex polyurethane improved concrete discharge and minimised build up, significantly reducing the cleaning time from four hours a week to just one and eradicating the risk of blockages at the mixer gate.

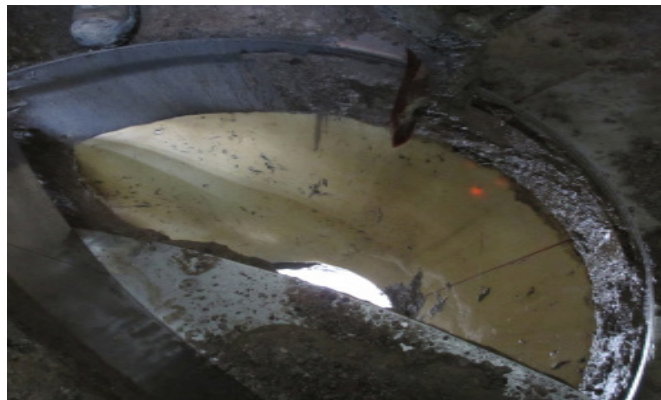
ConeFlex installation at CEMEX Widnes

The longevity of the ConeFlex is highly impressive. After 10 years, the ConeFlex is still operational and performing well. Furthermore, the light-weight chute liner was only rotated in the past couple of years, which will further extend its service life.

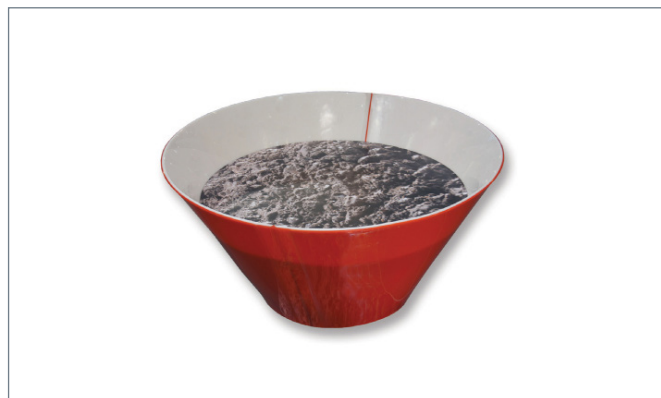
ConeFlex chute liner solution with dual layer wear indicator
