## ConSpareUltra *PLUS* vibration table liners cut the cost of downtime on concrete block machine

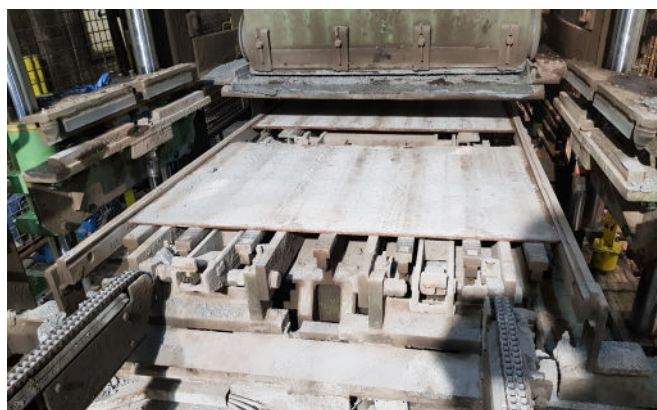
Block machine vibration table at client's factory

This was the case at a leading national producer of concrete blocks. Due to the level of abrasion and the use of steel production boards, the OEM's steel vibration table liners were wearing unevenly and relatively quickly. A shutdown was then required for the vibration table to be maintained, with the liners replaced entirely and the table reset every 6-8 weeks.

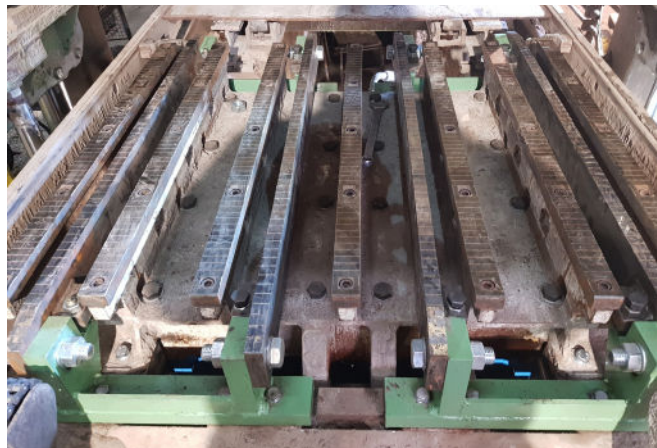
ConSpareUltra PLUS providing 4 years service-life

The difference in performance has been staggering, with the first set of ConSpareUltra PLUS lasting 4 years before replacement, compared to the OEM steel vibration table liners lasting just 6-8 weeks. This means the Ultra PLUS set lasted almost 30 times longer, with 29 fewer changeovers, 29 times less installation downtime and 29 fewer sets of liners purchased over four years.

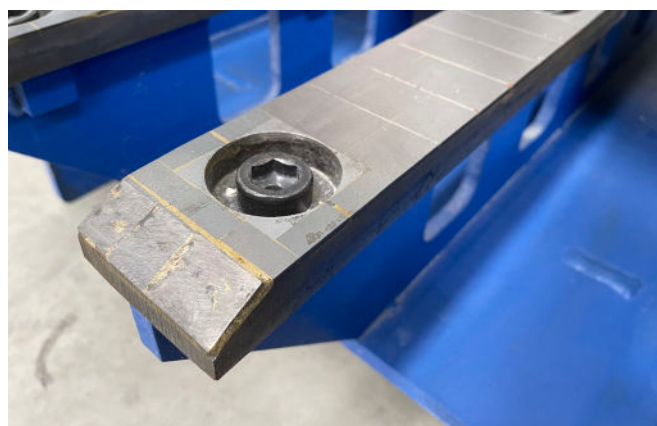
Special tungsten carbide segments developed for application

Steel boards present a challenging application to vibration table liners and ConSpareUltra PLUS uses specialist tungsten carbide facing segments which combine extreme abrasion resistance, a low co-efficient of friction and higher impact resistance.
