## BFM® fitting eliminates cement leakage and blockages during mixer loading

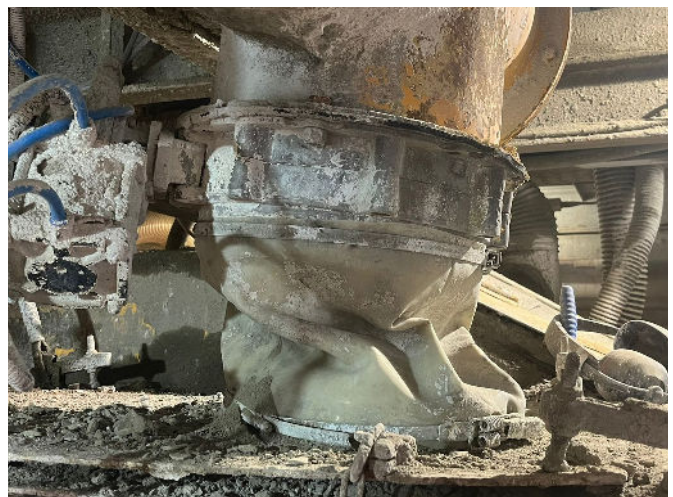
S Morris Ltd, a construction materials manufacturer, were experiencing cement leaking from a connector on the inlet to the mixer at their concrete and screed plant. Jubilee clips were used to secure the ill-fitting connector, providing an inconsistent seal. As a result, cement continually leaked during batching.

As the connector was ill-fitting, there were also many creases in the sleeve where cement accumulated. Cement would then bind with moisture from the mixer, causing blockages in the sleeve.

Jubilee clipped connector on cement inlet above mixer

S Morris Ltd contacted us to discuss the BFM® fitting solution. The system is comprised of two specially formed steel spigots welded to inlets/outlets and an industry-leading BLUEBAND™ flexible connector. Crucially, BFM® flexible connectors snap internally within the spigots, creating a 100% dust tight seal.

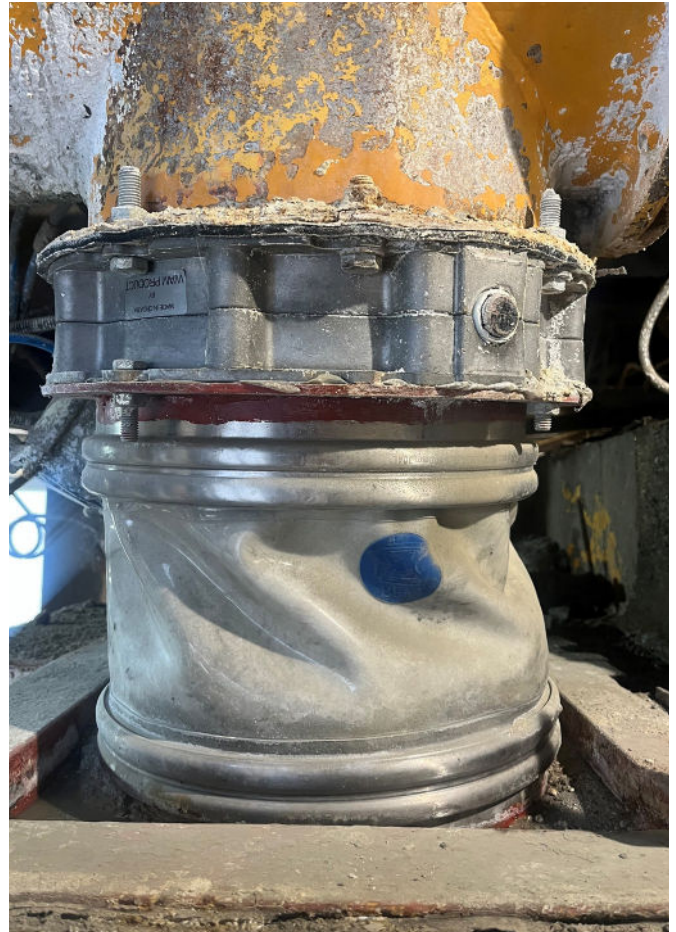
BFM® fitting installed on cement inlet above mixer

BFM® fitting has completely eliminated cement leakage on the inlet to the mixer. Previously, staff spent ~20 minutes after each shift cleaning the mixer area and platform. Cement is kept in the process now, not only keeping the mixer platform far cleaner, but also reducing cement wastage. Moreover, approximately 72 hours have been saved in clean-up time so far.

Similarly, staff were previously removing the old connector every day to clear blockages that had accumulated in any creases. In contrast, BFM® fitting offers a smooth internal surface for product to flow over. It only gets removed once a month now as part of regular housekeeping. What's more, this is still the same flexible connector that was installed over a year ago.
