Plant reliability problems solved: Monitor KA Rotary Level Indicator

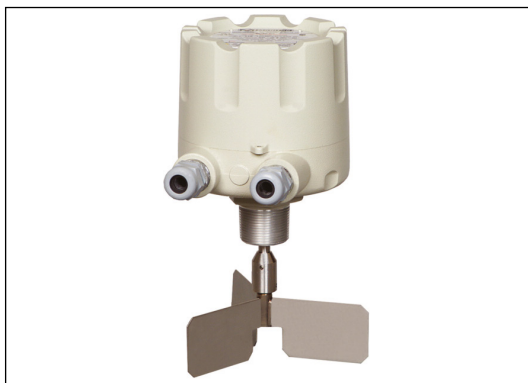
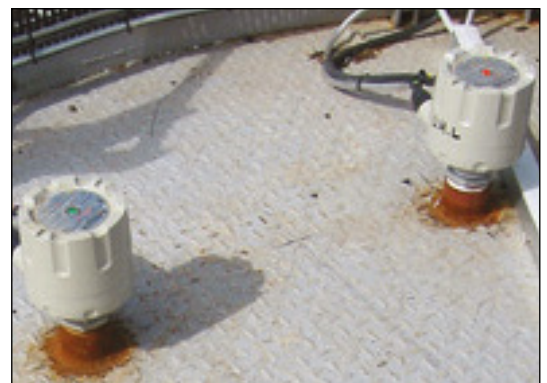
Our Solution: Monitor Model KA Rotary Level Indicator with flexible extension

Key Features: Robust, reliable design
Wide range of paddle / extension options

The Challenge: A major animal feed manufacturer was experiencing repeated level switch failure on their large silos. Corrosive finished feed meant switches needed to be top mounted, but side loading on long, solid extension rods from shifting material was damaging bearings.

Improvement: Repeated motor damage eliminated
