Table liner adjustment made a thing of the past: Vibration Table Liners

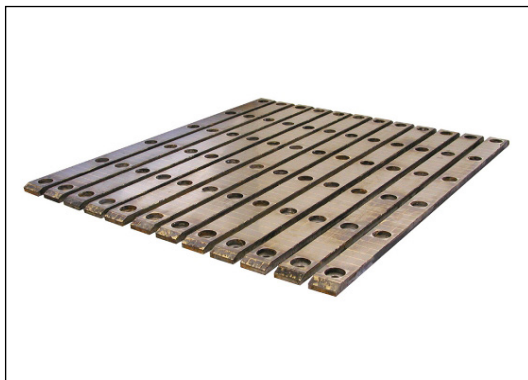
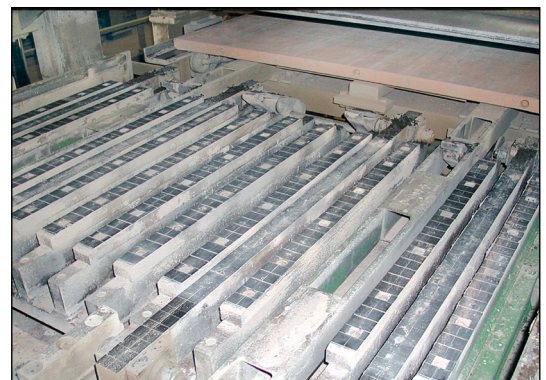
Our Solution: ConSpareUltra tungsten carbide protected vibration table liners

Key Features: Highly abrasion-resistant, equivalent to 90+Rockwell

Improvement: **Case hardened steel:** 5 hours of adjustment every 3 months
UltraTungsten: No adjustment in over 12 years and still operational
