Build-up eliminated, maintenance hotspot eradicated: Matrox Low Friction Lining

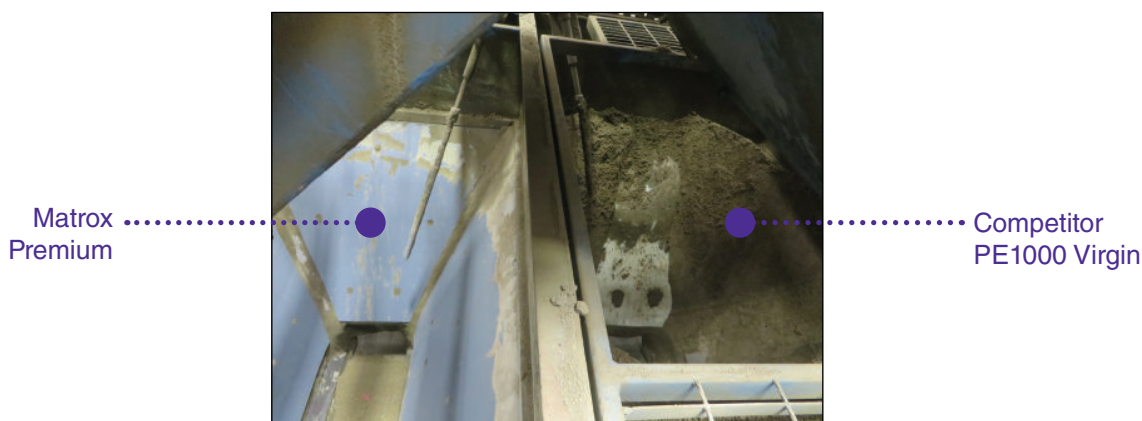
The Challenge: A leading Roof Tile manufacturer was experiencing severe build-up in a number of PE1000 lined holding hoppers. The dry concrete mix was sticking to the hopper walls disrupting production. Operatives regularly agitated the encrusted material using a rod, this action caused damage - allowing product to build-up and set behind the liners. Eventually, the set concrete would then fall into the screw-feed & damage the flight.

Improvement: PE1000 Virgin: constant build-up, cleaned every 15 minutes
screw flight regularly damaged & replaced

Matrox Premium: no build-up, no cleaning, no damage

Our Solution: Matrox Premium grade UHMW polyethylene

Key Features: Lowest surface friction, special additives enhance performance
